**Do88 WC-290 Test Fitment Report
BMW F20 M135i Pre-LCI**

4 October 2022

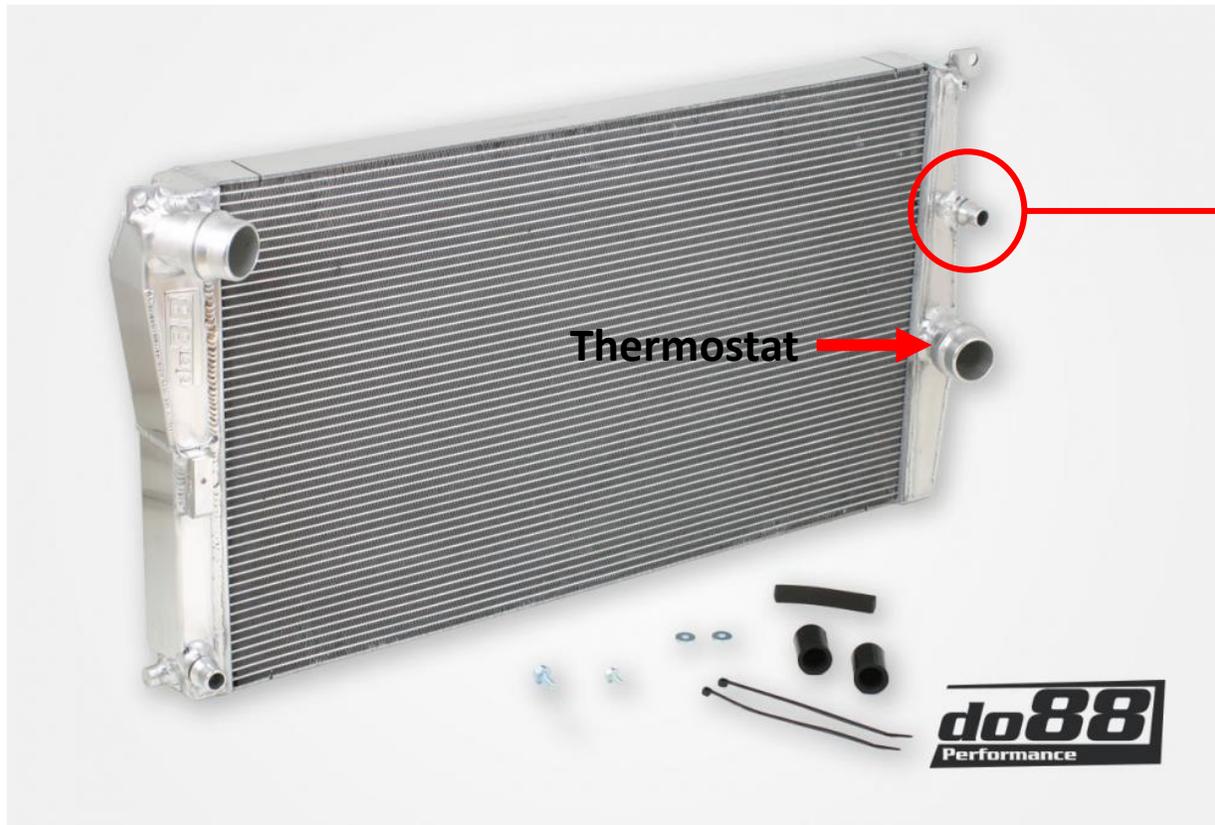
WC-290

OEM Equivalent: 17118672103

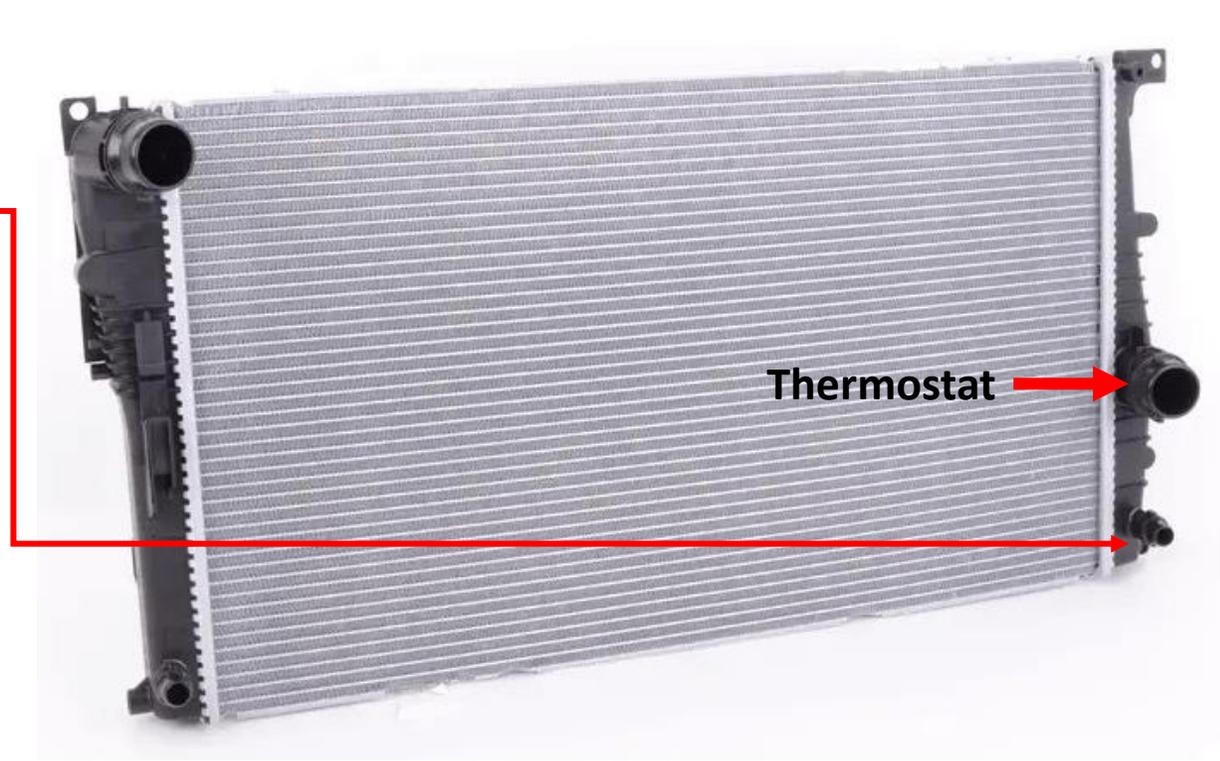
BMW F20 M135i PRE-LCI

OEM Equivalent: 17118672104

The coolant return port found on customer vehicle, BMW F20 M135i Pre-LCI is positioned below the thermostat. All other connectors remain the same.

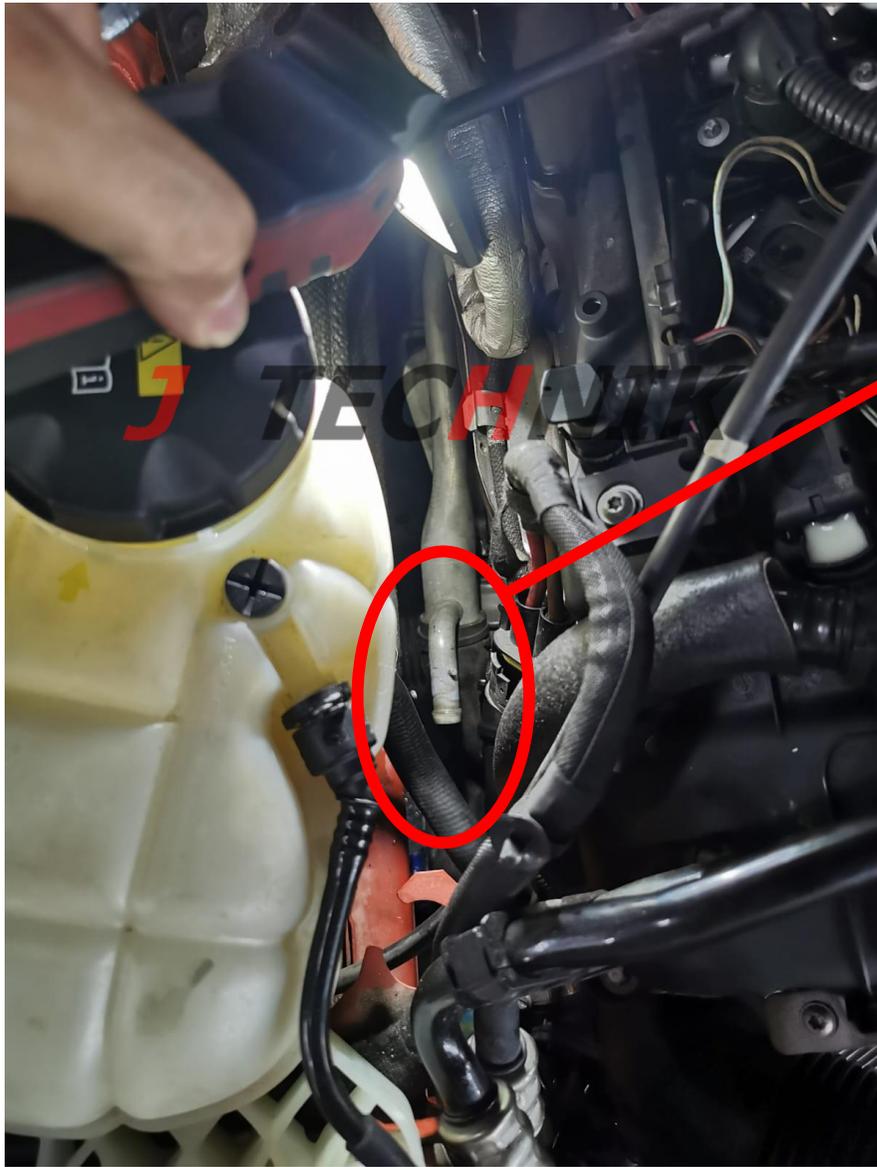
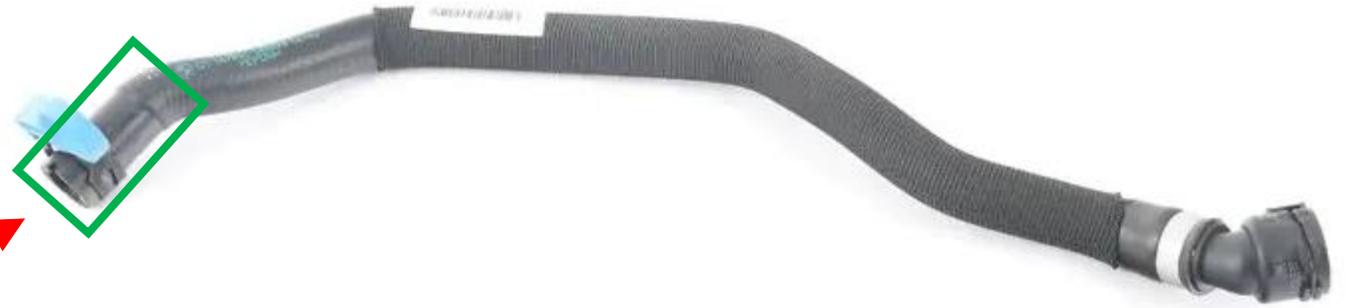
- Replace existing coolant return line with 17127648644 (picture above)
- From the tail end of the pipe, cut out approximately 5.5cm (indicated in green)
- The tail end of the pipe is essentially a reducer (large to small diameter), after cutting away the excess it can be difficult to install the pipe. We recommend to add some grease to aid the installation process

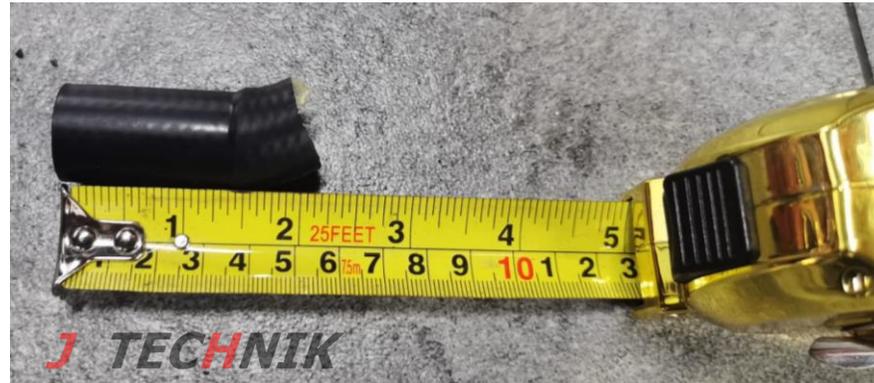
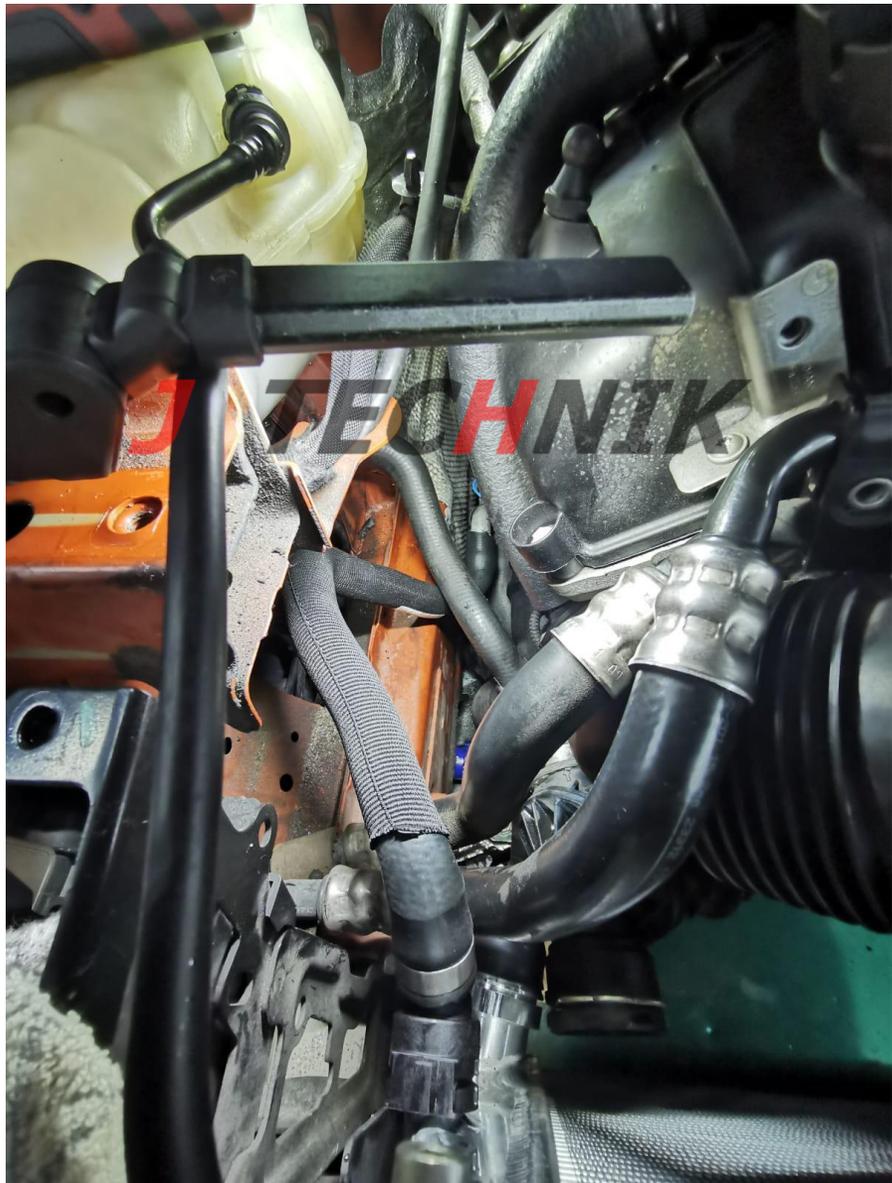
- With the new coolant return line now ready, route it under the thermostat pipe, and away from the thermostat and oil lines.
- Ensure that the new coolant return line does not have any kinks
- If there are kinks present, you may cut away approximately 0.3-0.5cm from the tail end and re-fit the pipe
- Ensure the tail end of the new coolant return line is fitted snugly and installed with the **new spring hose clamp**

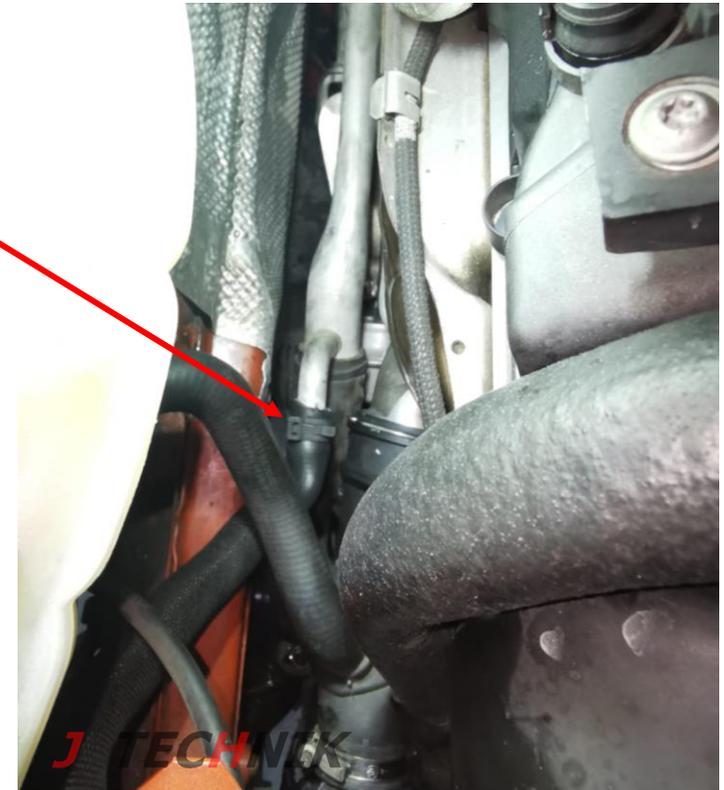
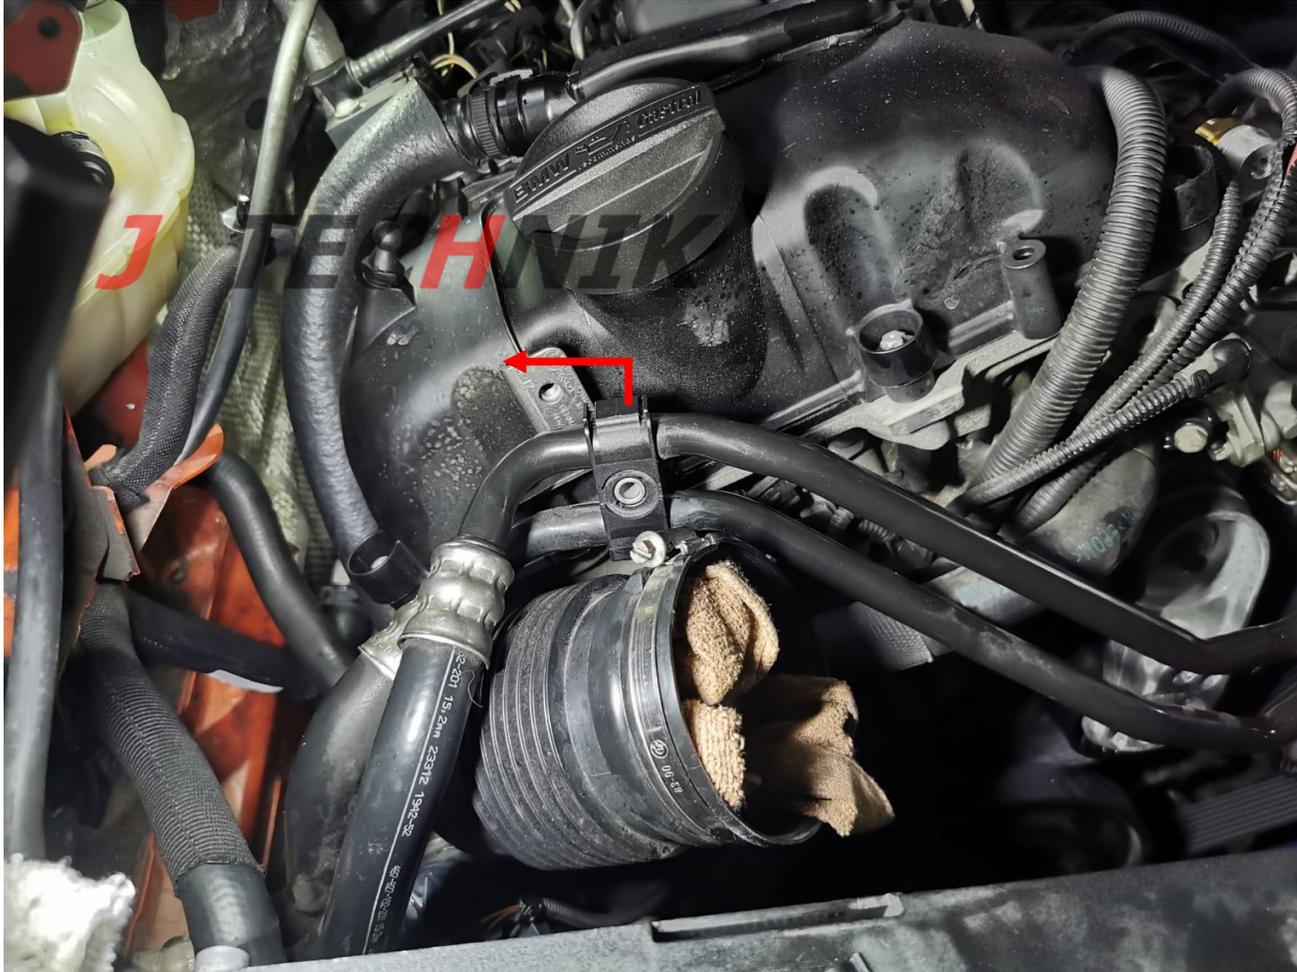
- With the oil pipe holder, shift to the left as much as possible
- This pulls the oil lines slightly away and this avoids contact between the new coolant return line and oil lines
- No bracket required to change its position
- Re-attach oil pipe holder with the existing 10mm nut.

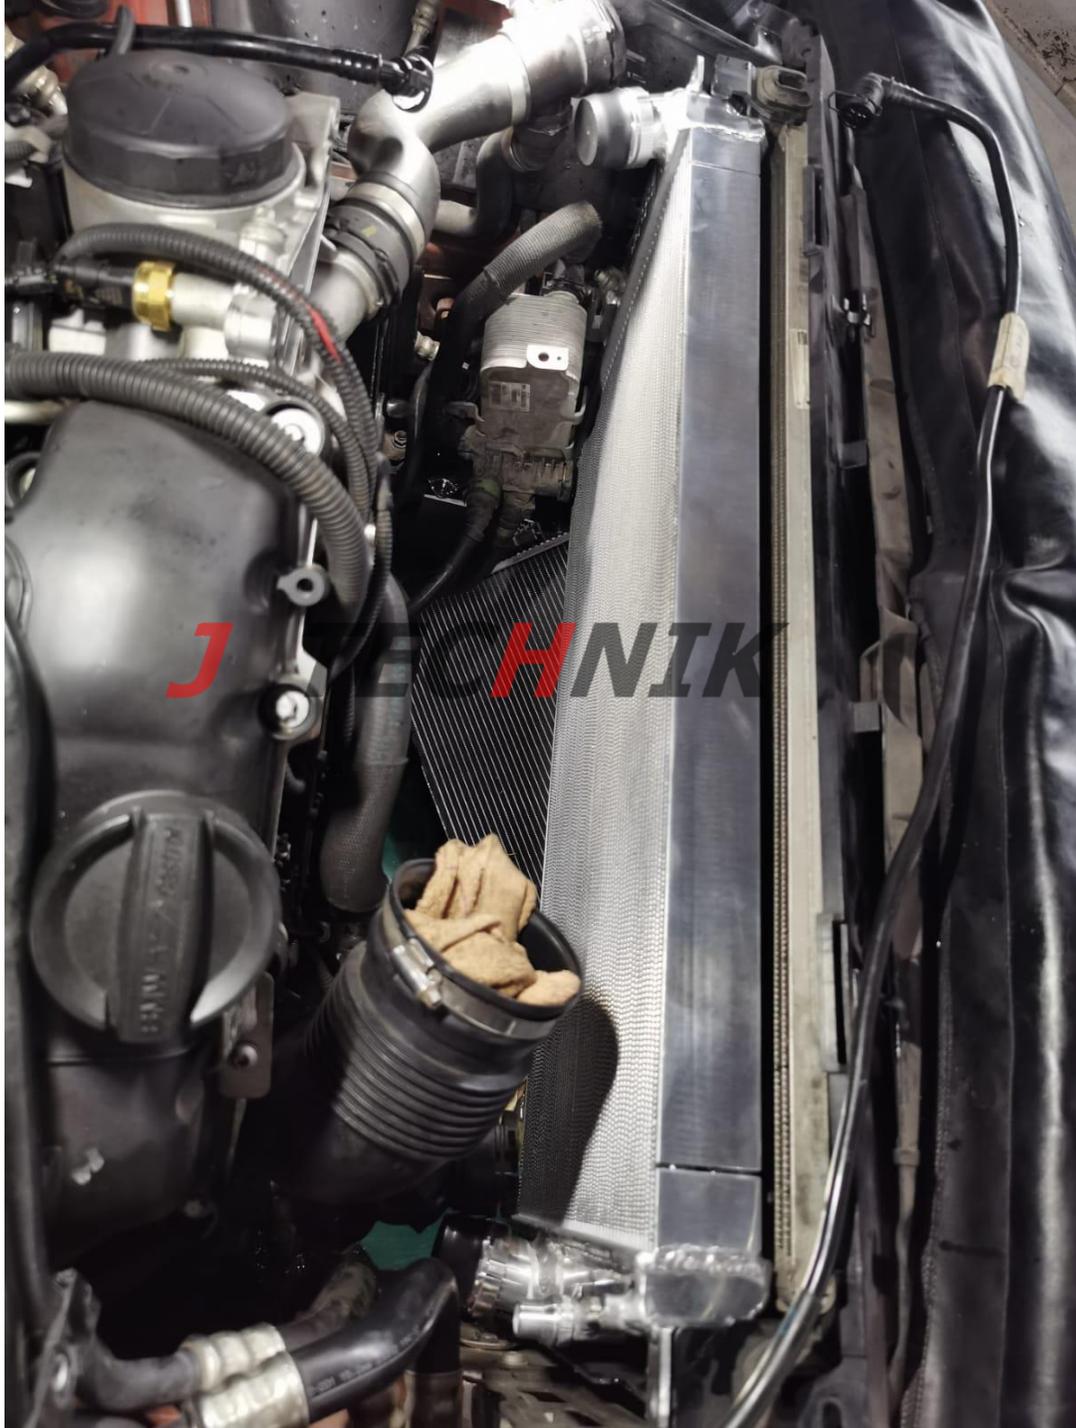
- Radiator fits nicely with no issues
- Reconnect all coolant connections and perform pressure test.
- Reinstall all components and you are set!
